TECHNICAL EXPERT REPORT ON THE MECHANICAL STRENGTH AND STABILITY OF THE SITE HIGHSCHOOL Gf+2F WITHIN TECHNICAL ENERGY COLLEGE IN VIEW OF THE THERMAL INSULATION

Sibiu municipality, str. Energeticîenilor, nr. 1

S.C. EUROENVIRONMENTAL CONSULTING SRL

March 2025

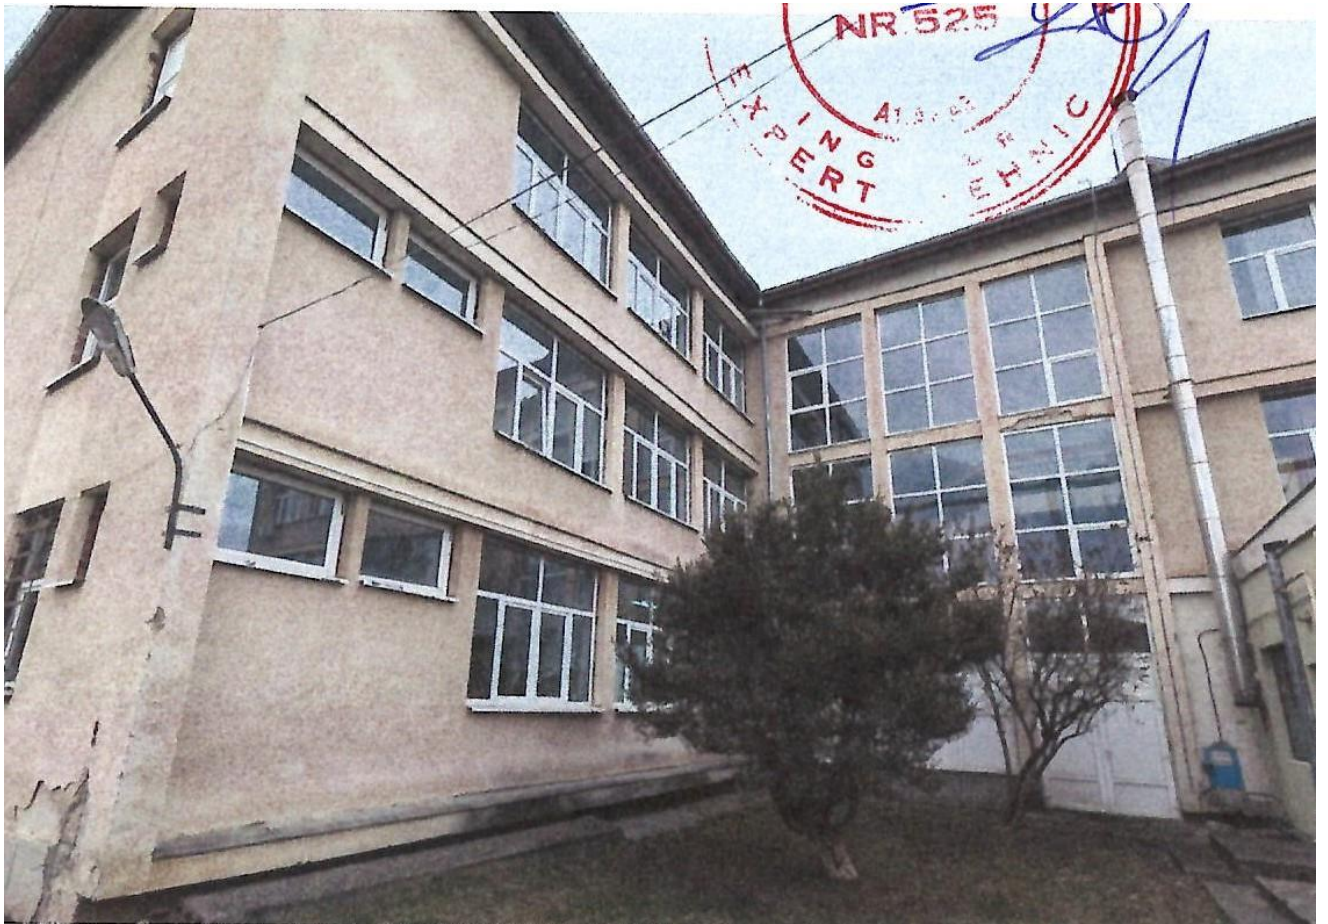
- the exterior plasters have depreciated, crumbling and partially exfoliated areas;
- the timberwork has some leaks,
- the sidewalk is detached from the wall and has a reverse slope on certain sections. In some areas the guard sidewalk does not exist;

Photo 3 – Photo from thermal system. Some plaster degradations can be seen.

Cladding the building with mineral wool and plaster does not bring significant additional loads and does not affect the integrity of the structural elements. Before enclosing the building, any defects in the structural elements will be repaired with epoxy mortars (chips, visible reinforcement, cracks, monolithics) as follows:

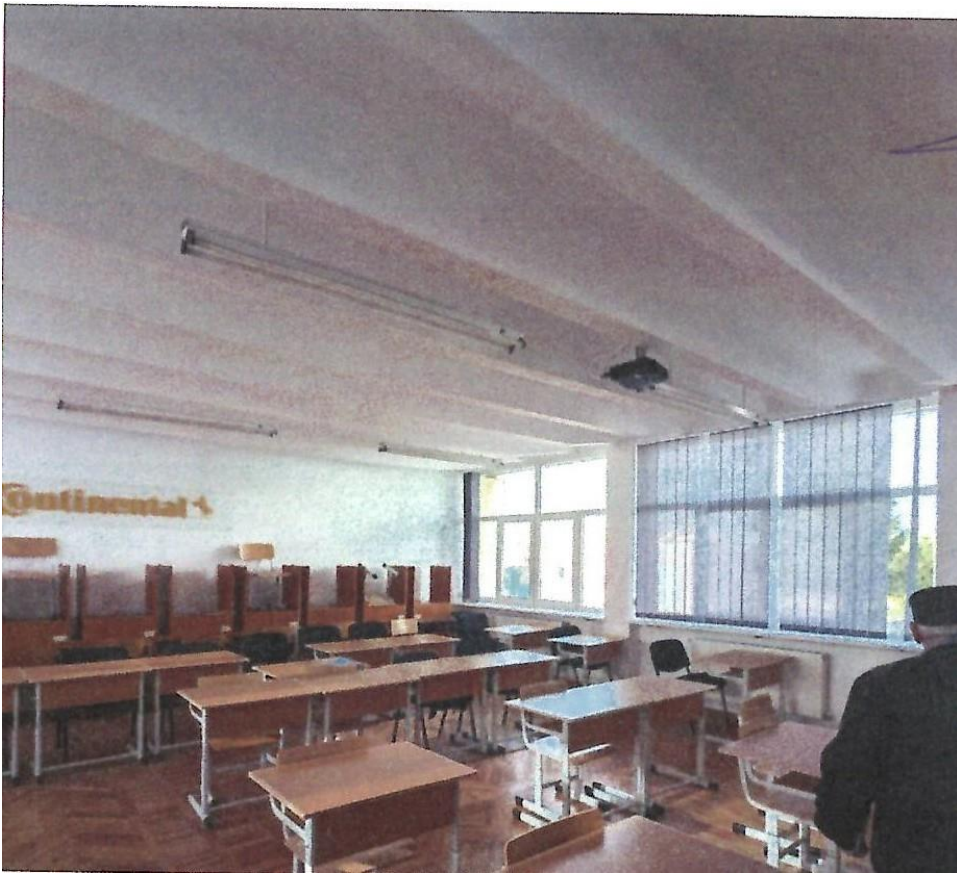
- The structural strength of the classrooms in building C is different from buildings A and B. They are provided with 25 x40 cm columns at a 3 m pitch similar to the other two buildings. The floors are made of 12x45 cm thick ribs, provided at a 75 cm pitch over which a 7 cm reinforced concrete slab was poured.

Photo 5. Photo in the classroom of building C shows the floor with dense ribs.

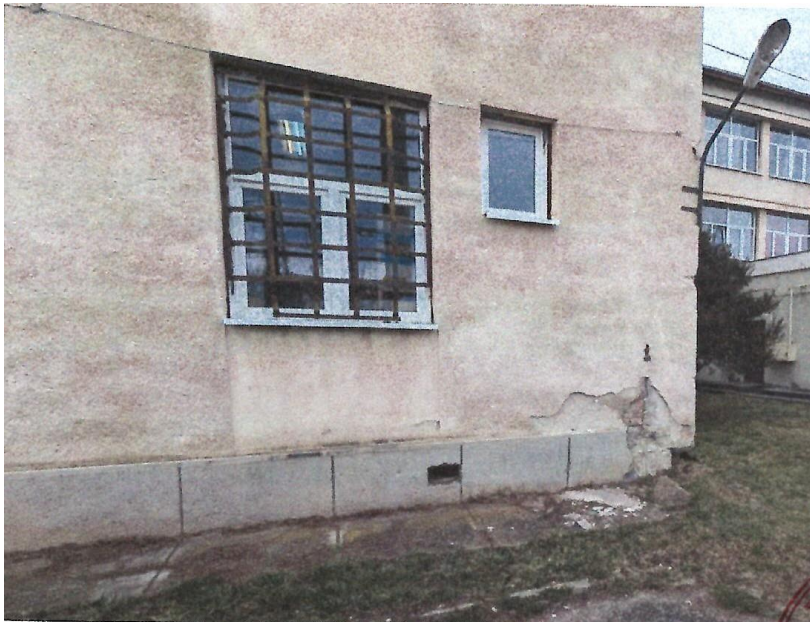
Photo 6 - entrance photo. one can see some parts on which the plaster fell and the absence of the guardrail on one side

- the building will be surrounded by new sidewalks with appropriate slopes, sealed against the walls with bitumen plugs and the plaster of the plinths will be repaired where it is detached.

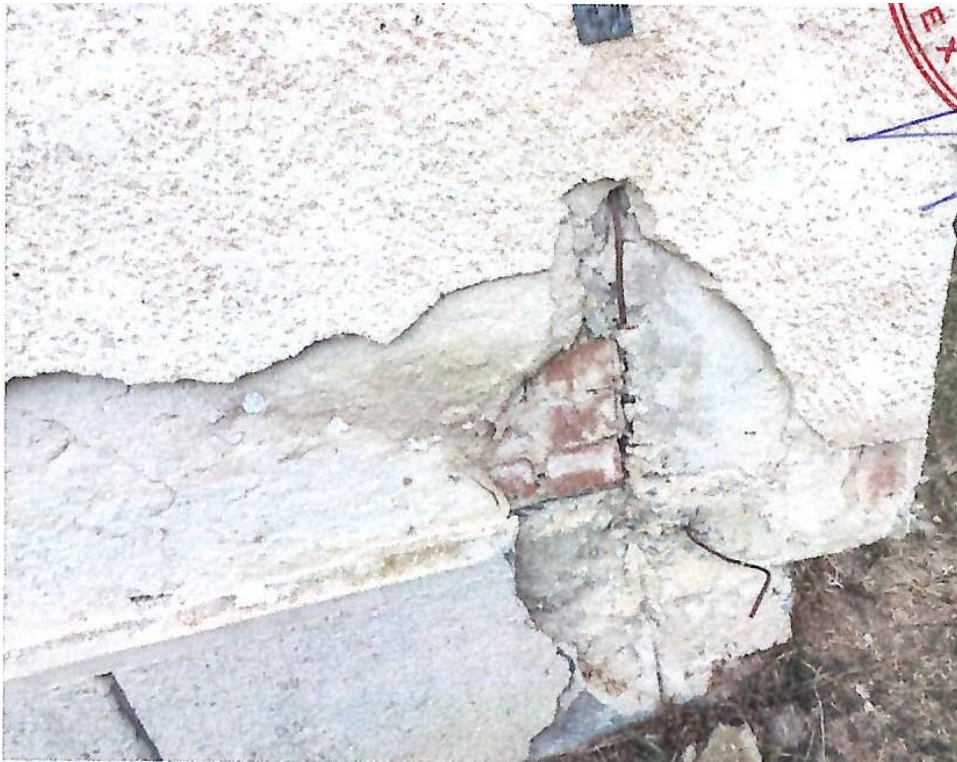
Photo 7 - one can see the corner reinforced concrete column

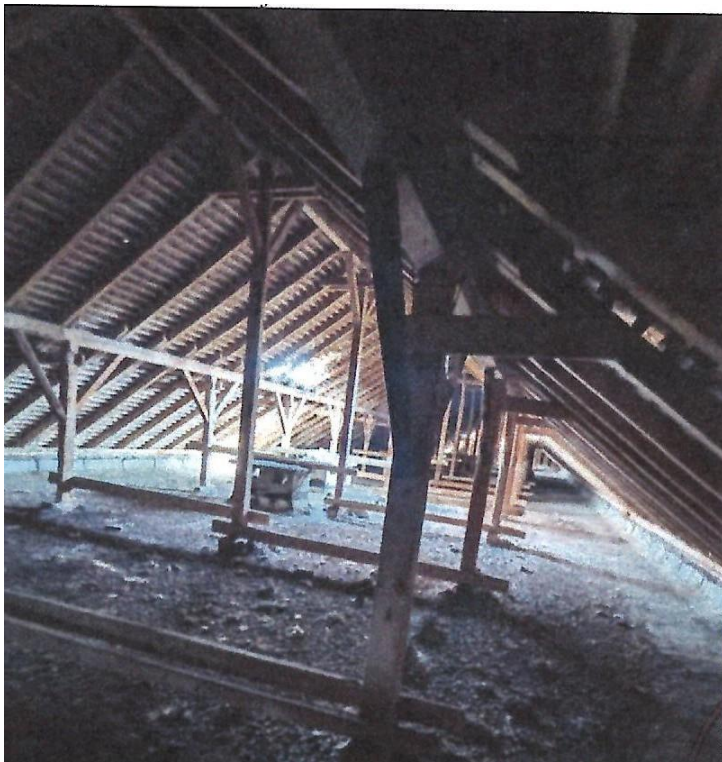
Compared to the initial project, a framework with a wooden structure and ceramic tile covering was created. The framework has a height of 4.20 m at the ridge, where props are provided at a distance of 3 m and a ridge wedge. The panels have 15x18 cm sections. The rafters have a 10x12 section and are provided at a step of 70 cm. The props are braced.

Photo 8 - Photo from the attic , one can see the shoring props, panels and rafters spaced at 70 cm

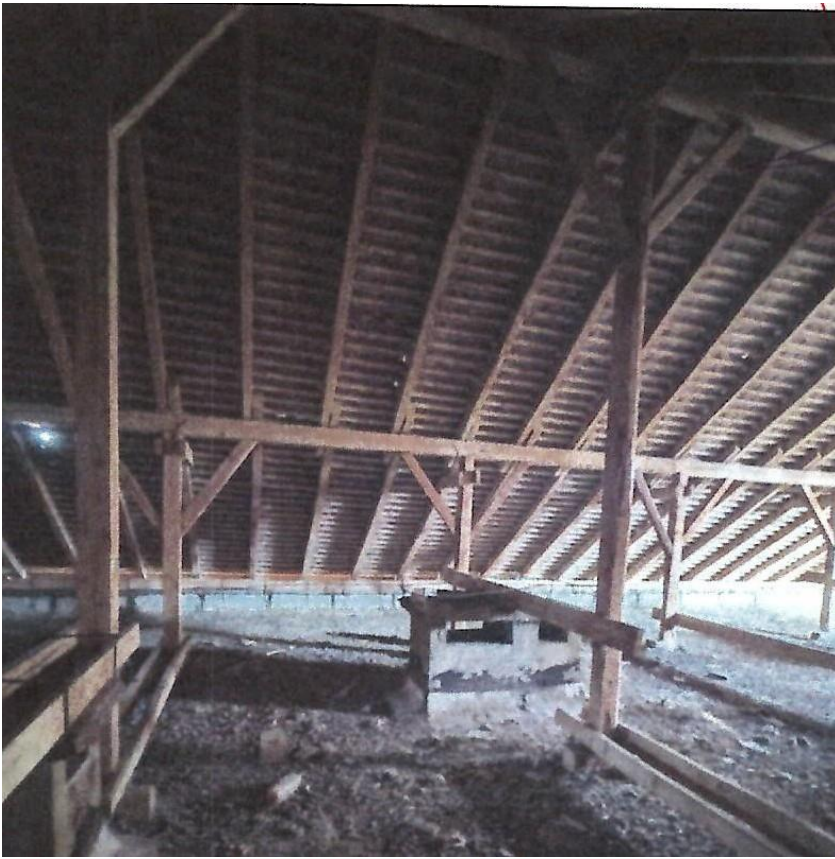
Photo 9 - Photo with the additional framework structure

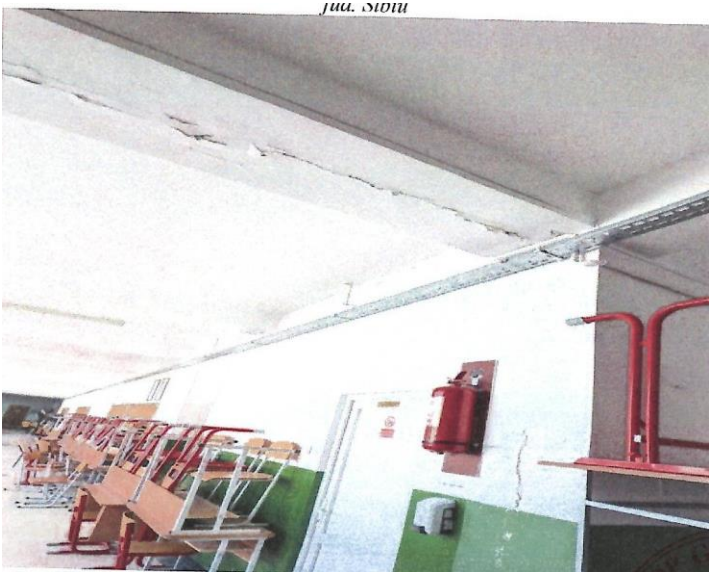
- the joint between the sections is not properly solved, and the plaster with which it is covered has cracked.

Photo 10 - Joint between section A and C improperly treated

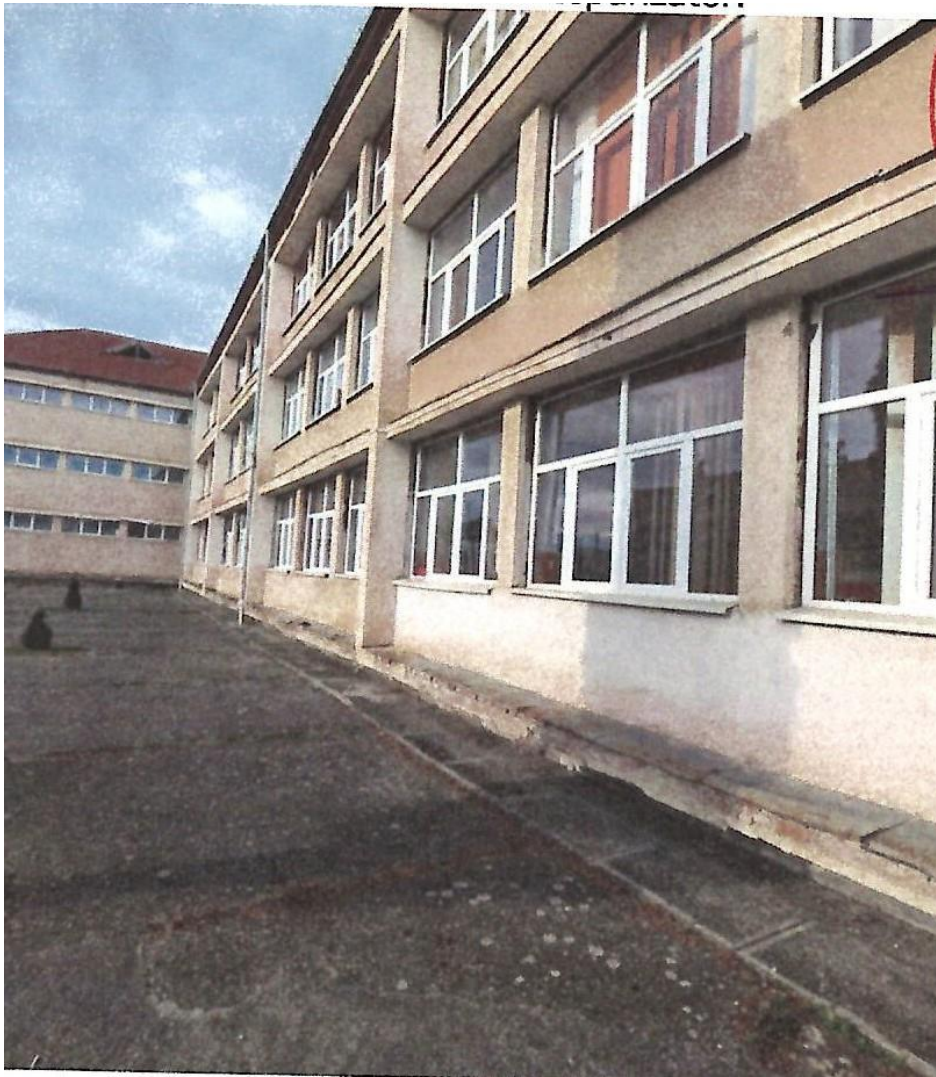
Photo 11 – Entrance from Electricienilor street. One can see the brice-soleil with the plaster fallen.
