TECHNICAL EXPERT REPORT ON THE MECHANICAL STRENGTH AND STABILITY OF THE SITE
STUDENT DORMITORY Gf+3F WITHIN TECHNICAL ENERGY COLLEGE IN VIEW OF THE THERMAL
INSULATION

Sibiu municipality, str. Electricienilor, nr. 1

S.C. EUROENVIRONMENTAL CONSULTING SRL

March 2025

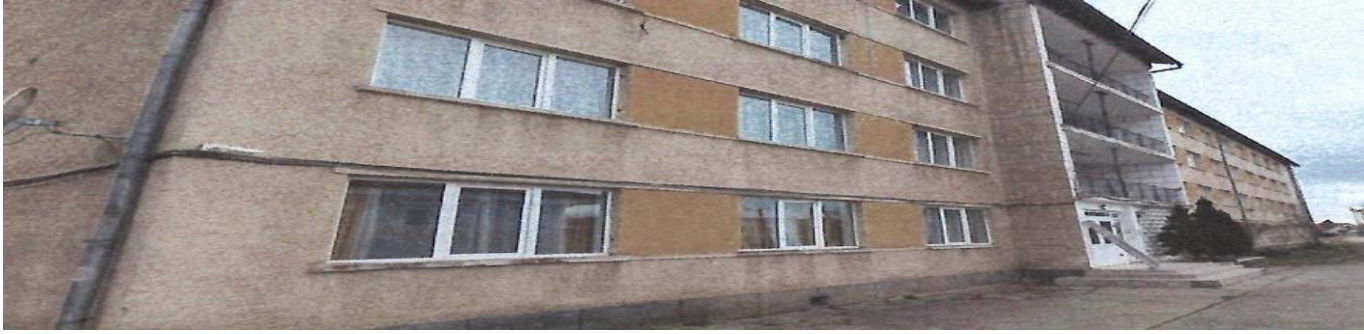
Photo 1 – Main entrance. Some infiltrations can be seen at the Annex socket.

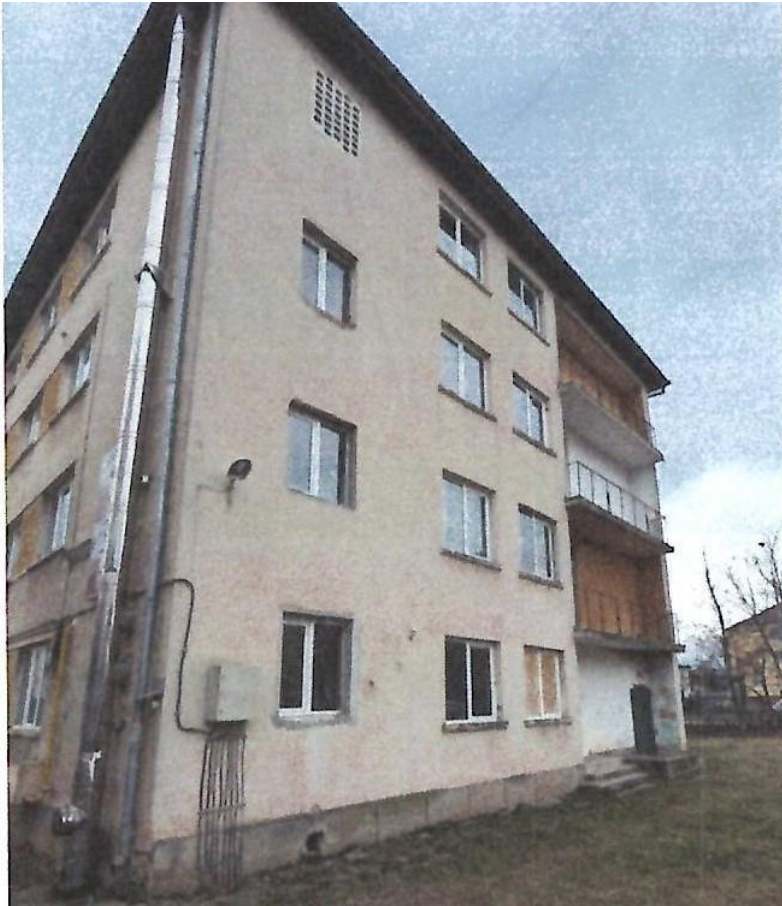
Photo 2 – Entrance from Vasile Aaron street, one can see the absence of a perimetral pavement

- measures will be taken to seal the joint between the sidewalk and the dormitory building
- the structure of the roof will be inspected and the degraded elements will be replaced.
- downpipes that are too short and without spouts will be extended to the ground and measures will be taken to remove water from the building;
- the building will be surrounded by new sidewalks with appropriate slopes, sealed against the walls with bitumen plugs and the plaster of the plinths will be repaired where it is detached.
- the installations that cause losses at the technical basement level will be identified and repaired.
- the compartmentalization changes can be made by providing concrete cores adjacent to the new door openings and by building the openings that are cancelled in strips.

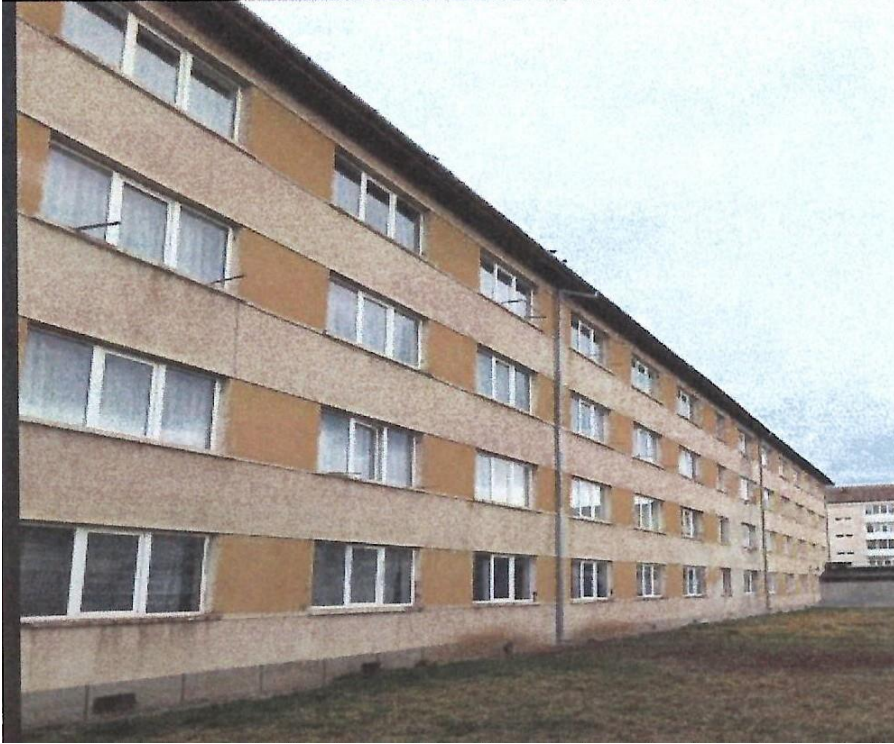
Photo 3 – Main entrance; damaged pipehole

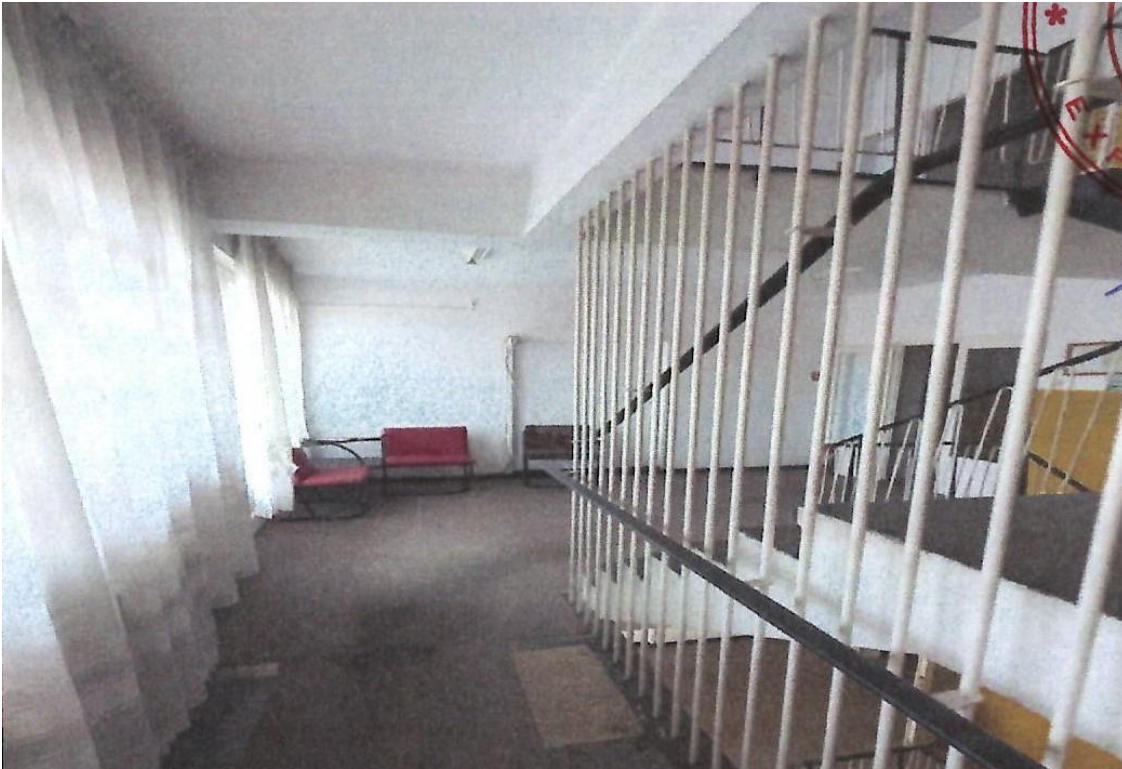
Photo 6 – Staircase area; one can see the reinforced concrete frames that support also the flight of stairs

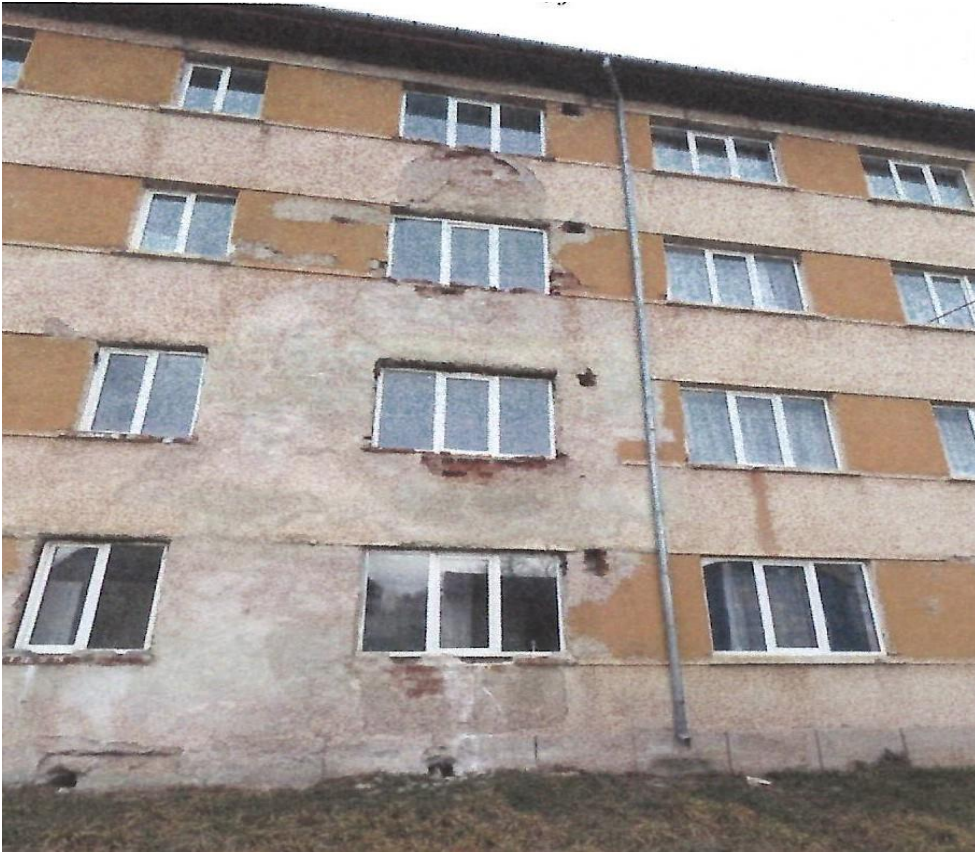
Photo 9 – Entrance from Electricienilor street. One can see the absence of the pavement and parts with the plaster fallen

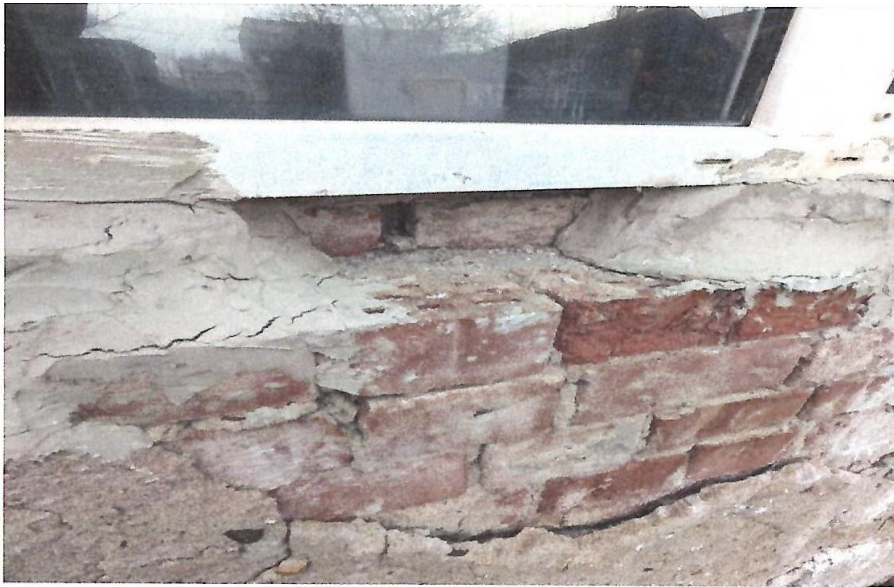
Photo 10 – Areas with the plaster fallen and with apparent bricks
