TECHNICAL EXPERT REPORT ON THE MECHANICAL STRENGTH AND STABILITY OF THE SITE Gf-GYM WITHIN TECHNICAL ENERGY COLLEGE IN VIEW OF THE THERMAL INSULATION

Sibiu municipality, str. Energeticîenilor, nr. 1

March 2025

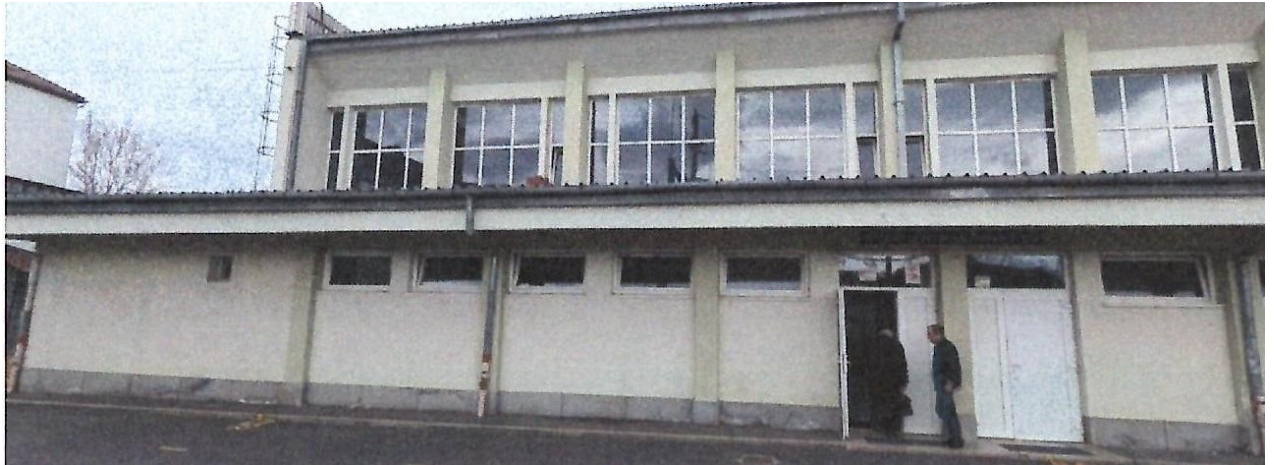
Photo 1 – Main entrance. Some infiltrations can be observed on the Annex socket

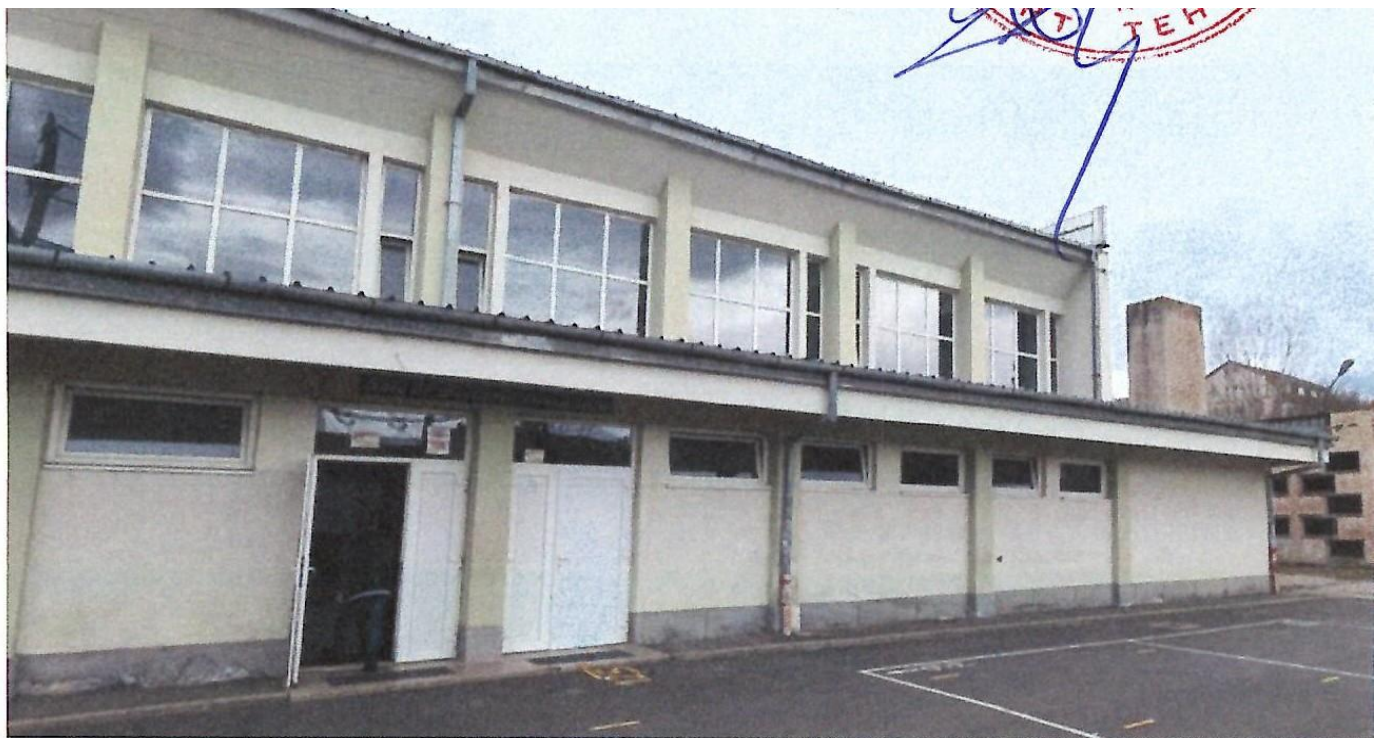
Photo 2 – Main entrance. Improper pipe

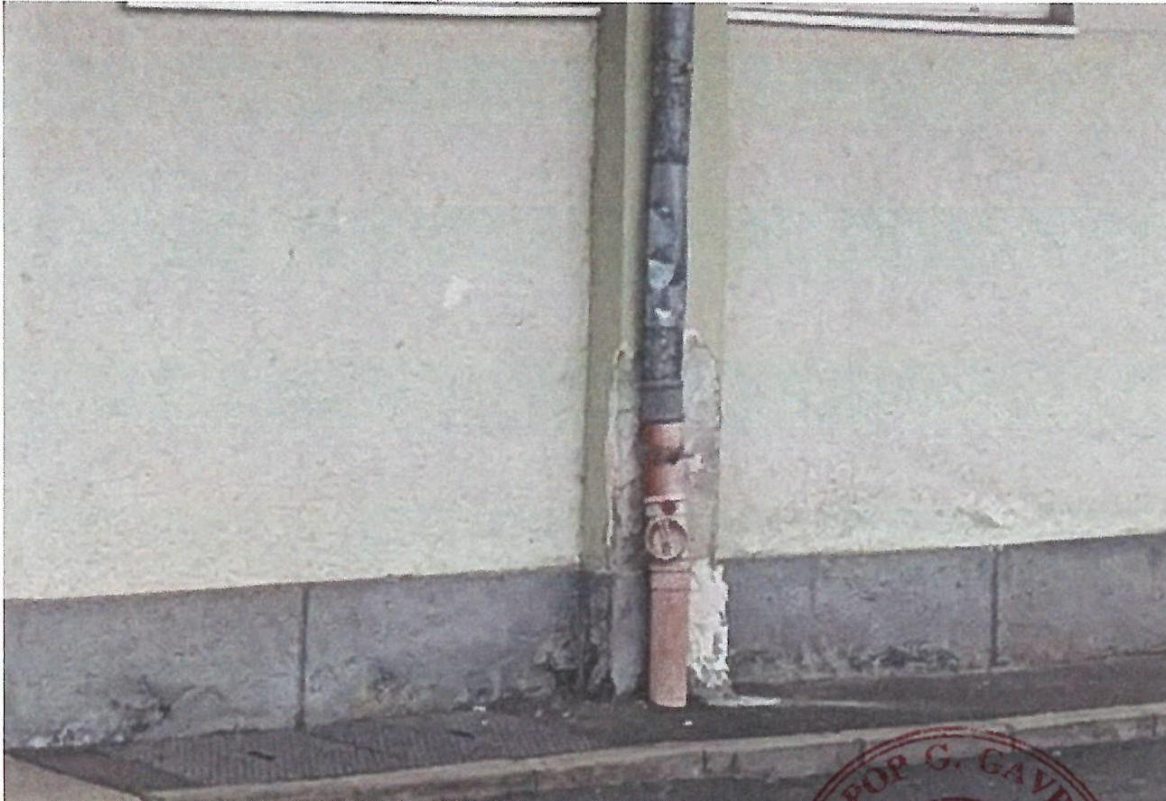
Photo 3 – Main entrance – damaged pipe

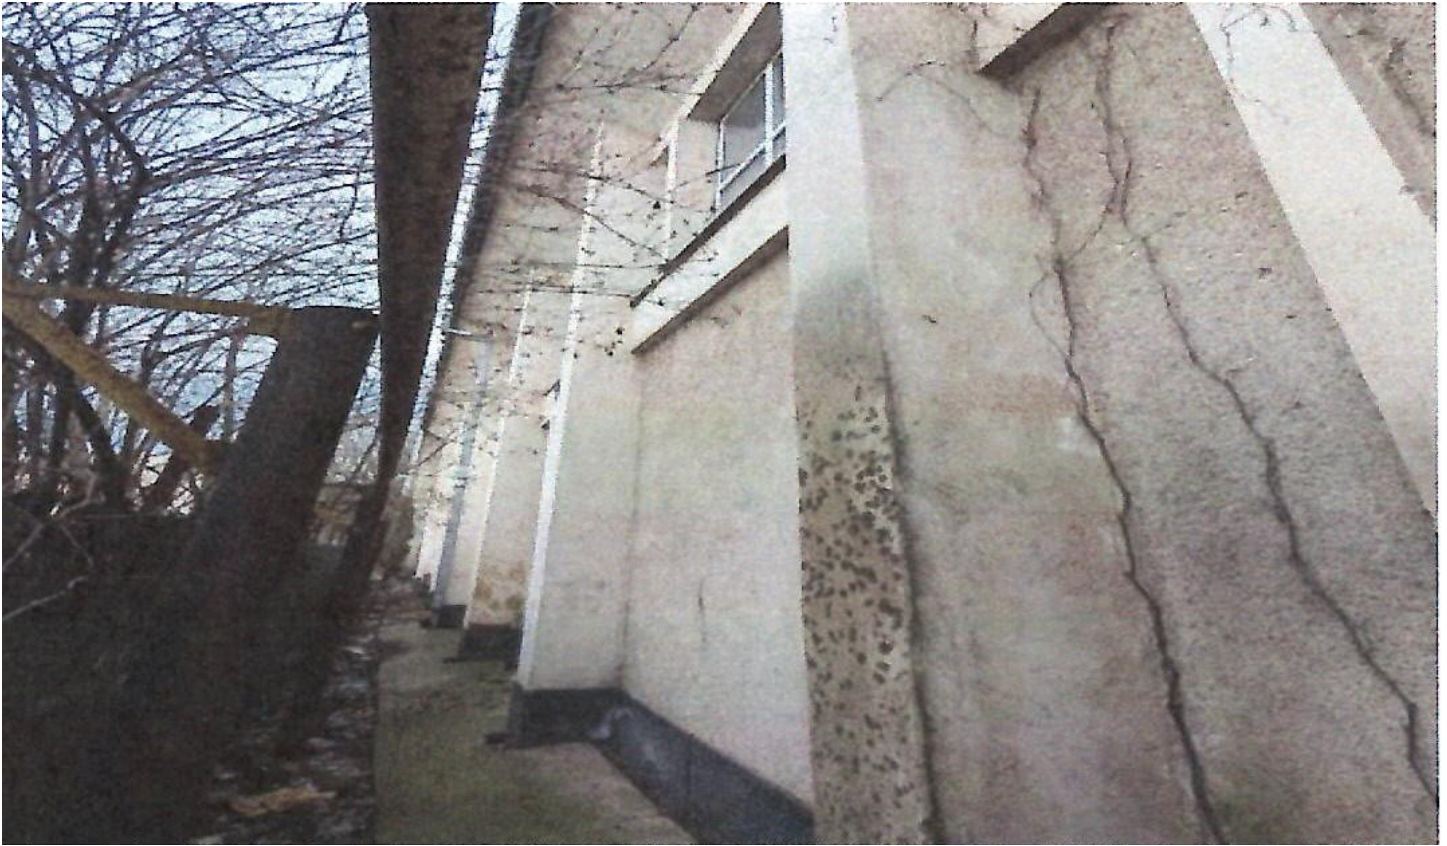
Photo 7 – Longitudinal wall with its entrance from the north side. One can see that the pavement detached itself from the construction and does not provide the removal of rainwater from the building.

- measures will be taken to remove accidental water losses
  - the building will be surrounded by new sidewalks with appropriate slopes, sealed against the walls with bitumen plugs and the plaster of the plinths will be repaired where it is detached.

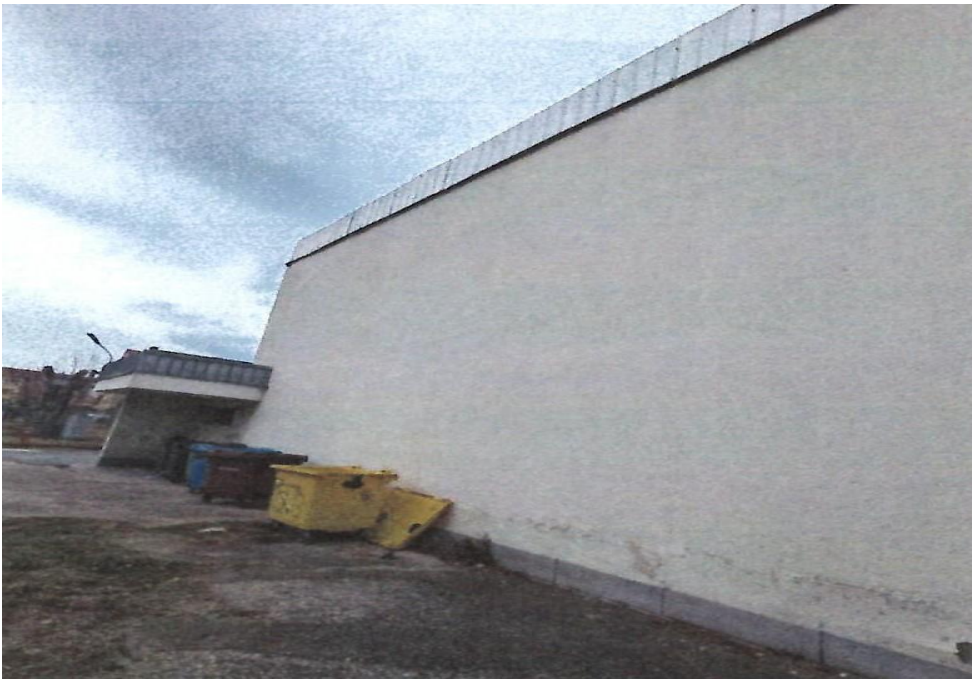
Photo 8 – Transversal right wall. One can see a wetting of the wall in the lower side, most probably due to the pavement with reverse slope.

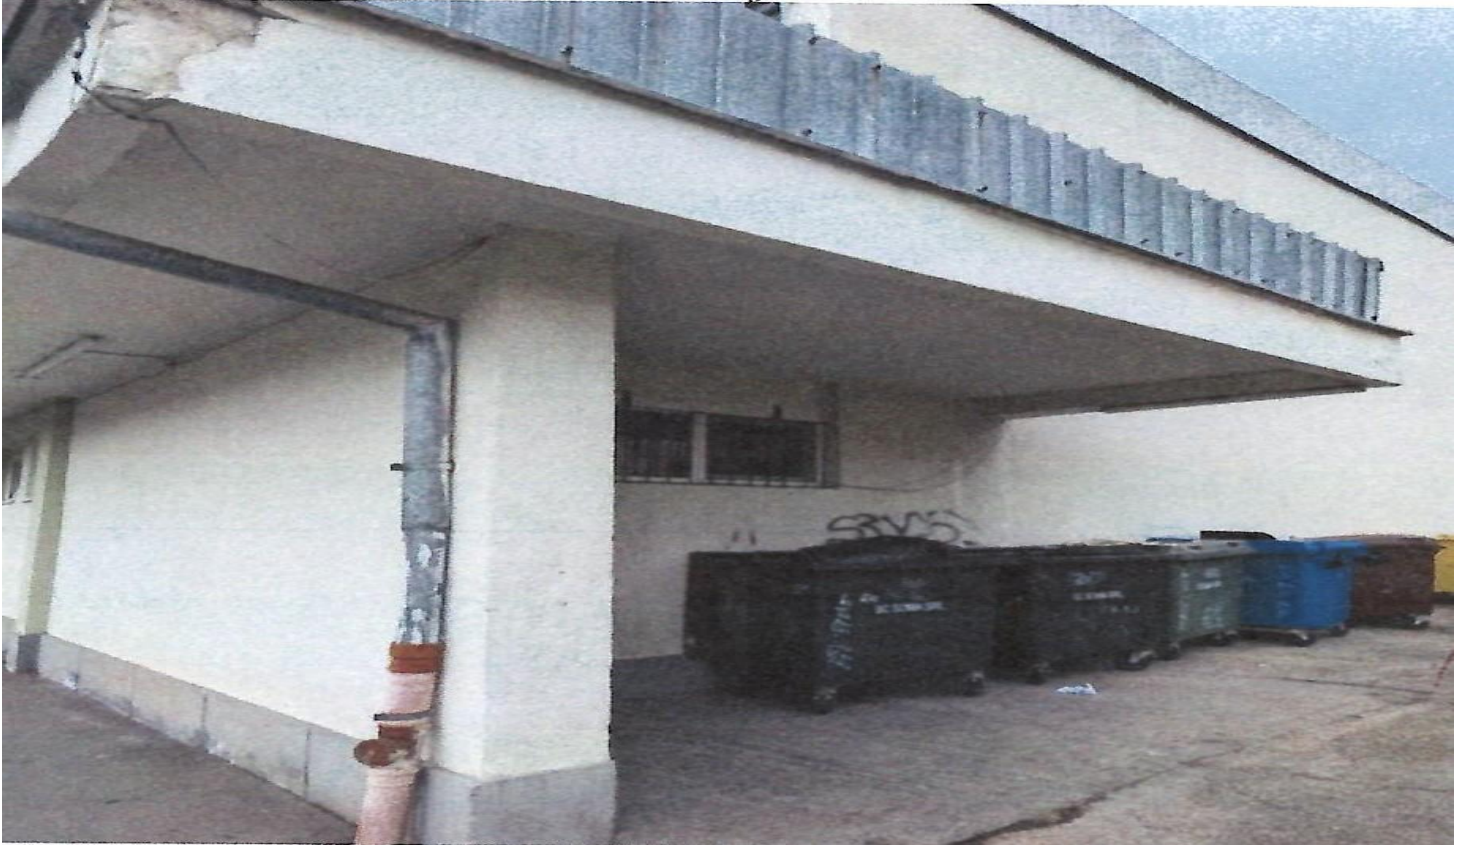
Photo 9 – Degradations of the concrete terrace plaster over the terrace.
