TECHNICAL EXPERT REPORT ON THE MECHANICAL STRENGTH AND STABILITY OF THE SITE
WORKSHOPS Gf+2F WITHIN TECHNICAL ENERGY COLLEGE IN VIEW OF THE THERMAL
INSULATION

Sibiu municipality, str. Energeticîenilor, nr. 1

Technical Expert
ENG. POP GAVRIL

March 2025

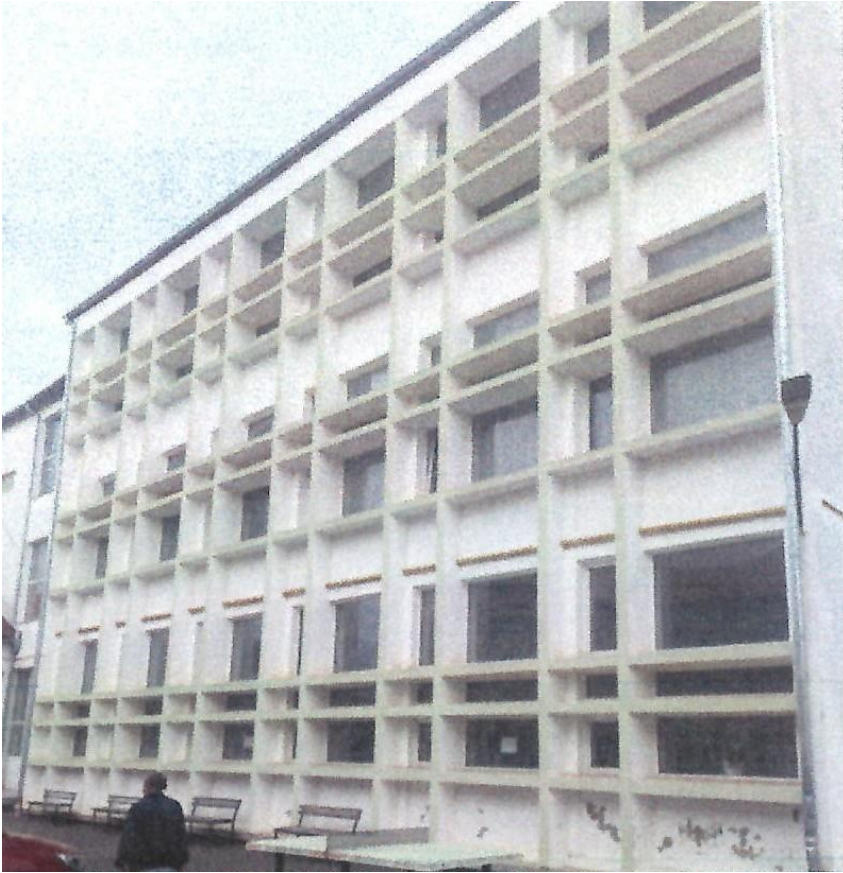
Photo 1 – Main entrance – one can see the brice-soleils from the laboratory level

- the current brice-soleils of the block Gf+2F will be removed
- a new reinforced concrete frame to replace the column cut into garage will be implemented

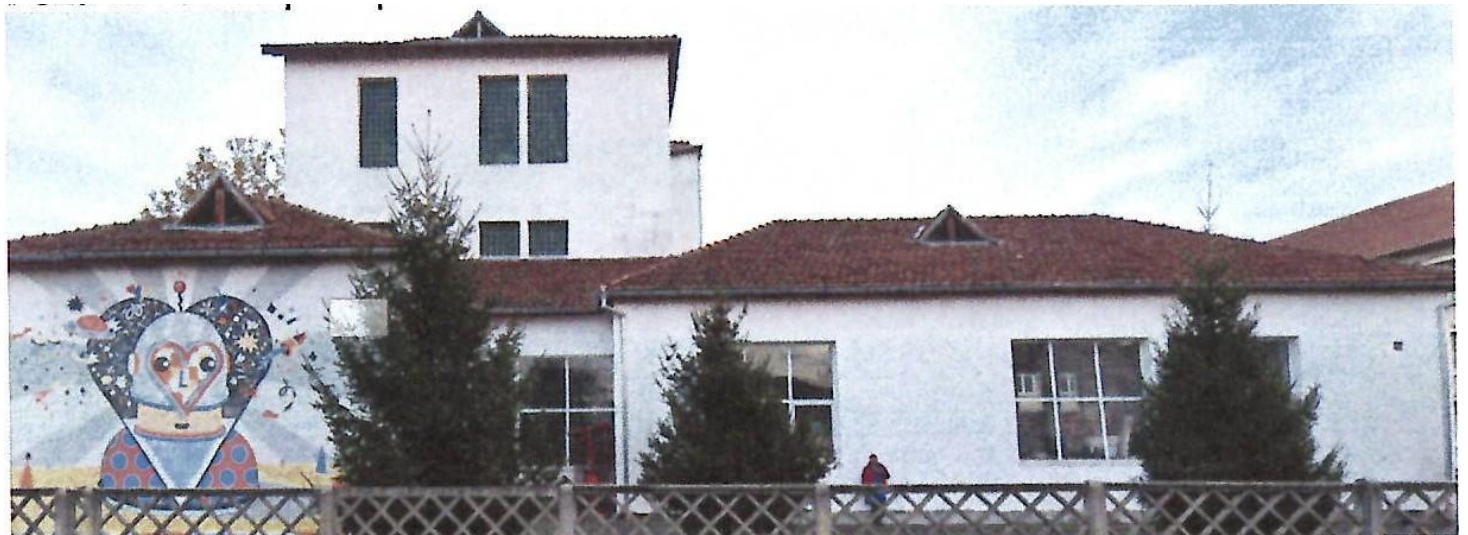
Photo 2 – Left side entrance from Vasile Aaron street. In the foreground one can see the block Gf Electric Workshop, to the left the Garage and in the secondary plan, the block Gf+2F

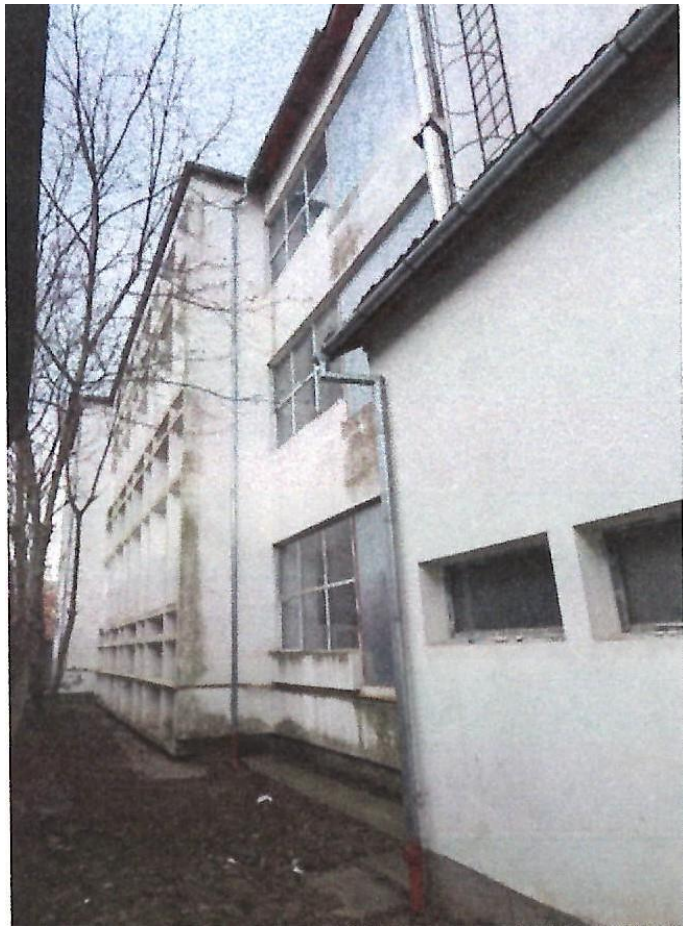
Photo 3 – Photo from the thermal system. One can see some plaster degradations.

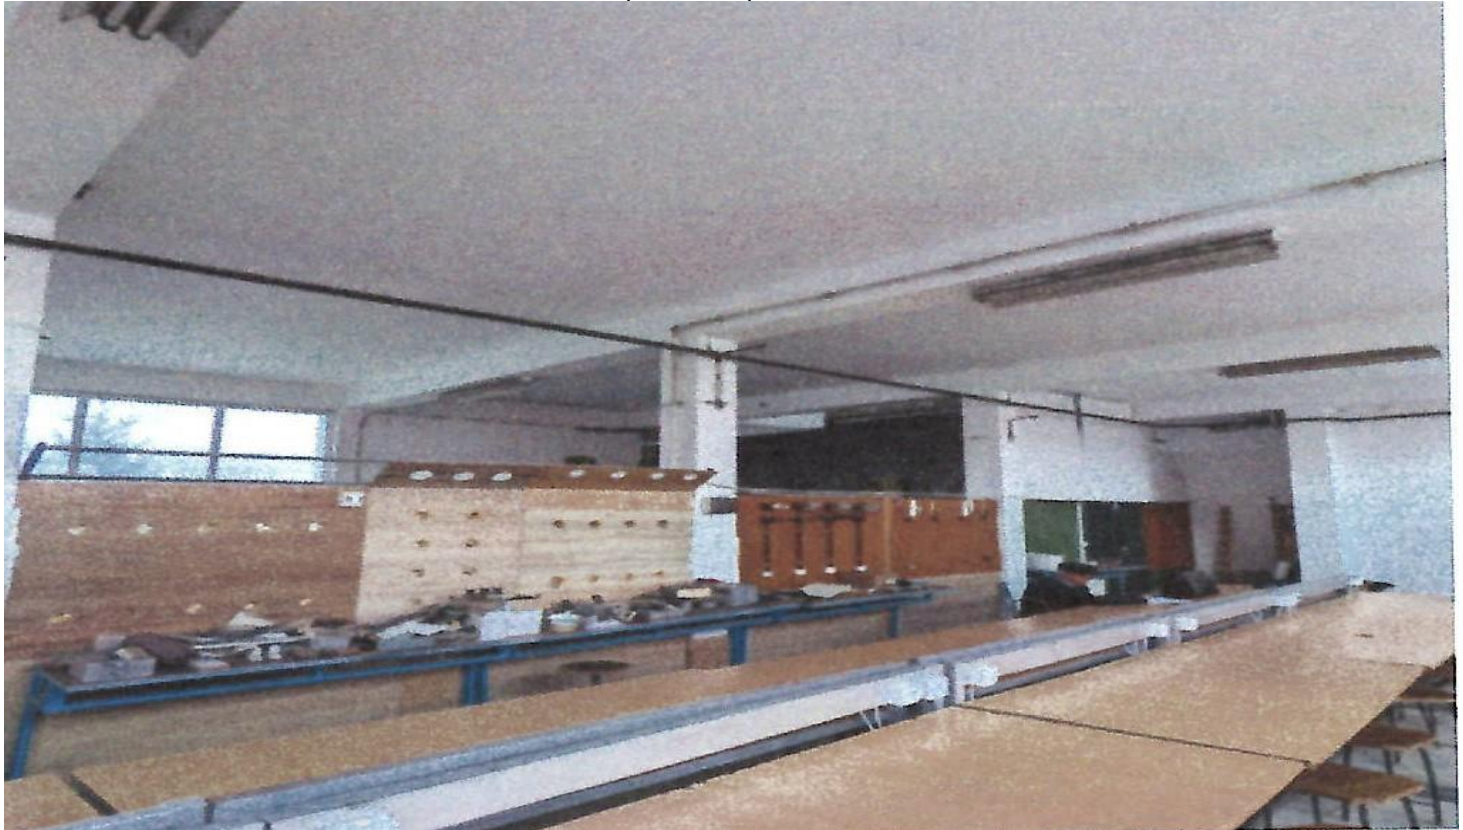
Photo 5 – Photo from Gf Electric Workshop. One can see the structure made of concrete frames of the building block

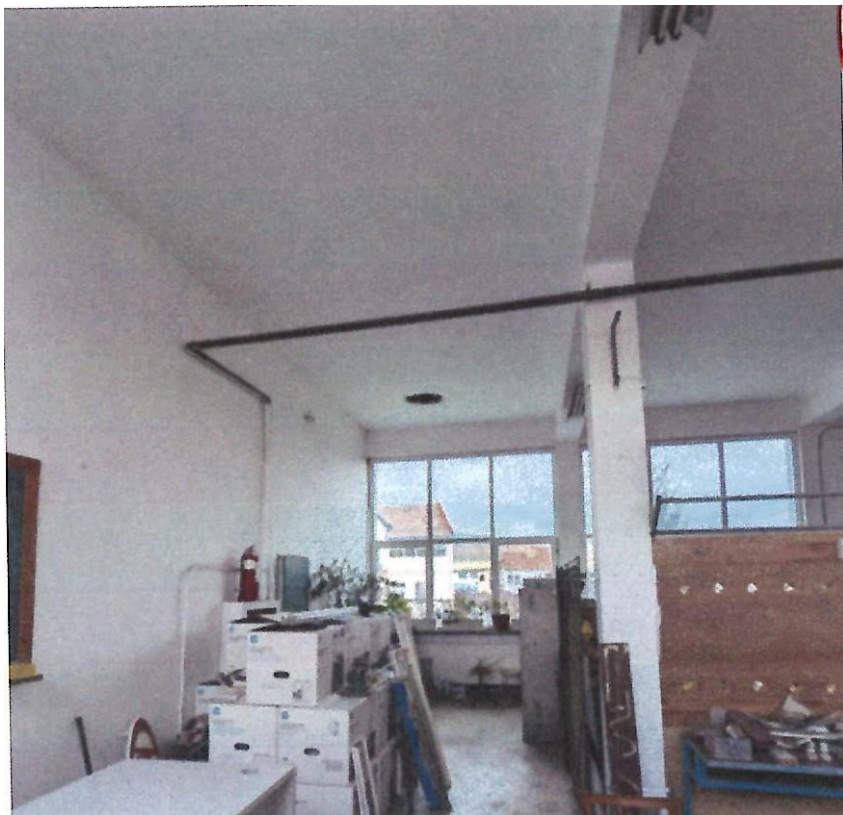
Photo 6 – Photo of the Electric Workshop block. One can see the structure in frames and in the left side the reinforced concrete walls

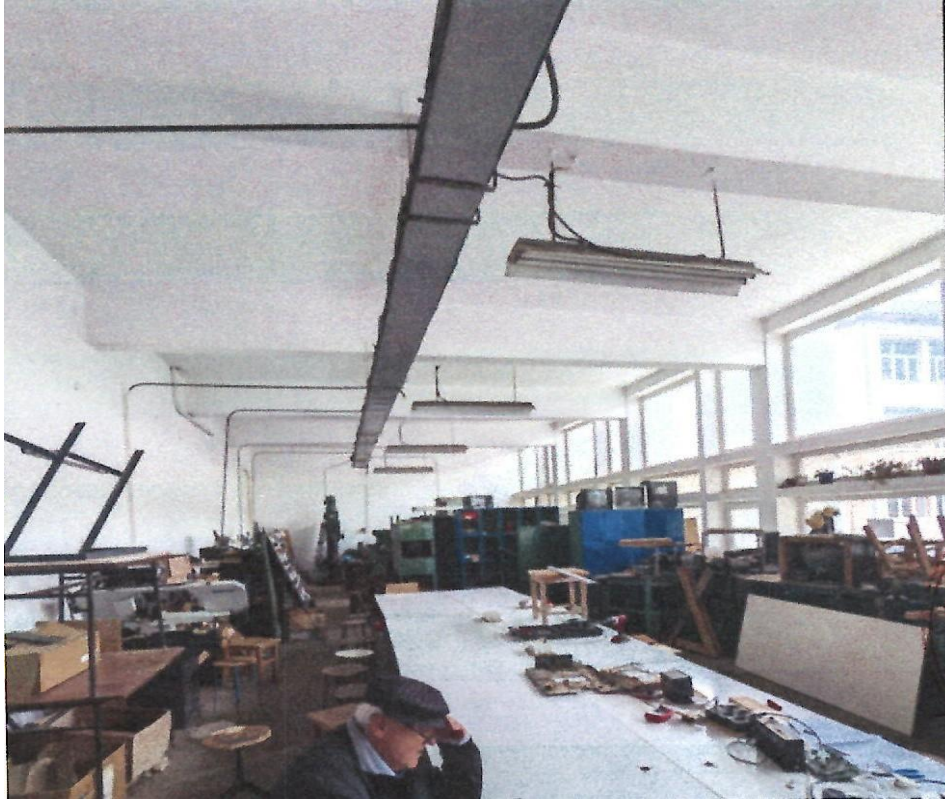
Photo 7 – Photo of the Gf+2F block, at Gf the Electrical mechanics workshop. One can see the median wall of masonry and the reinforced concrete frames

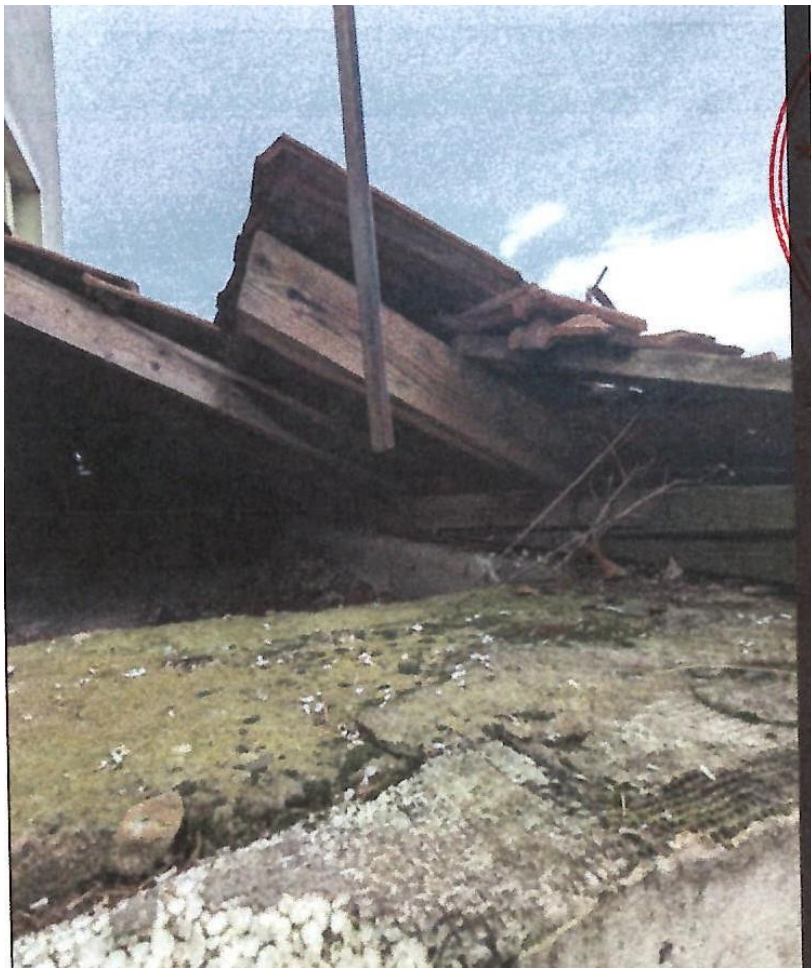
Photo 10 – Photo of the degrading framing on the Gf+2F block

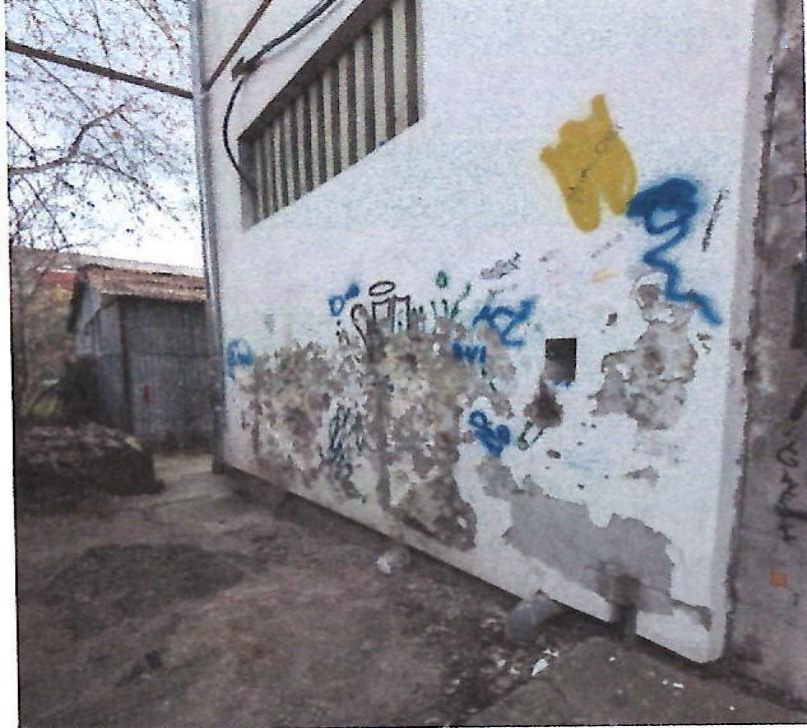
Photo 11 – Photo of the posterior entrance on the transformer station. One can see that the thermal insulation has been vandalized.

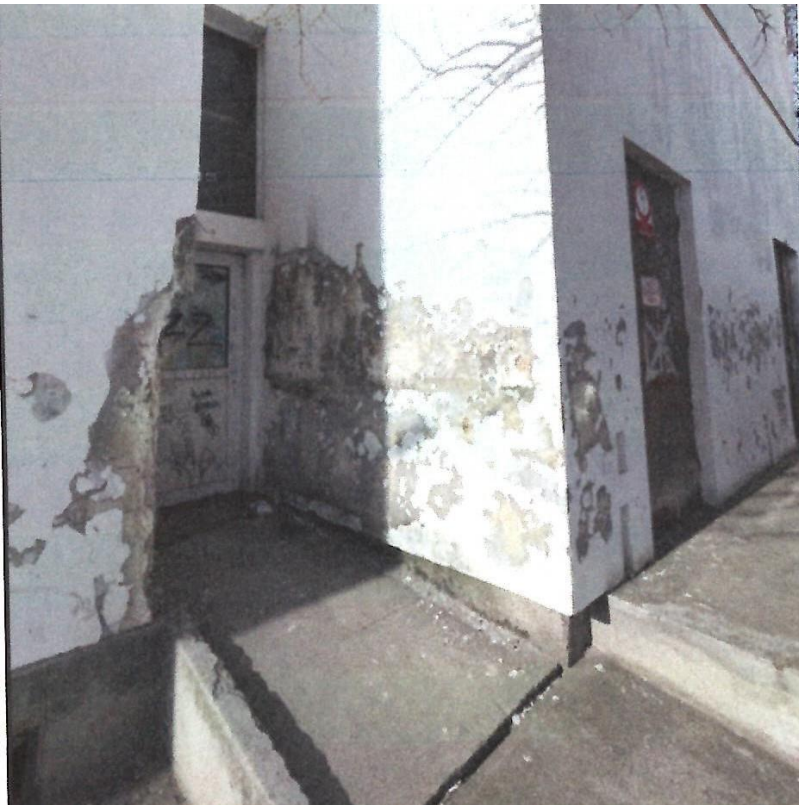
Photo 12 – Right side photo. One can see the secondary entries and the thermal insulation degradations.
