TECHNICAL EXPERT REPORT ON THE MECHANICAL STRENGTH AND STABILITY OF THE SITE Gf-GYM WITHIN TECHNICAL ENERGY COLLEGE IN VIEW OF THE THERMAL INSULATION

Sibiu municipality, str. Energeticîenilor, nr. 1

March 2025

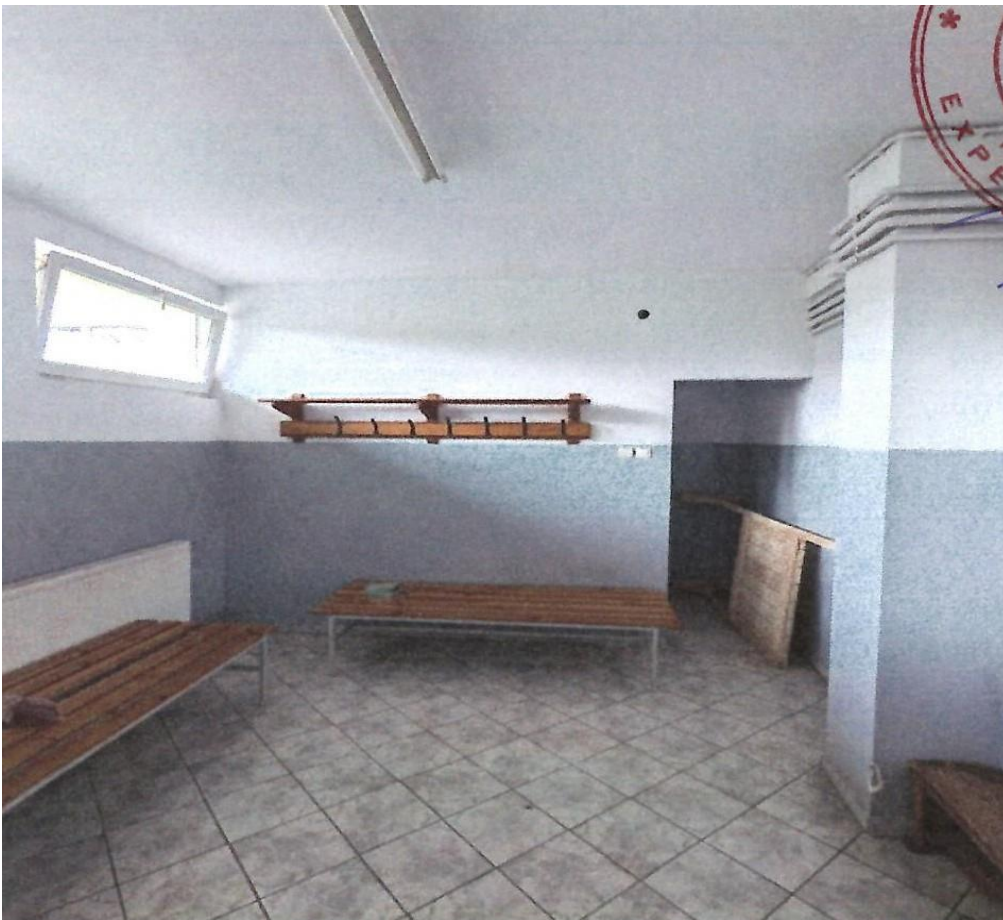
Photo 4 – Locker rooms – in the right side one can see a main pillar

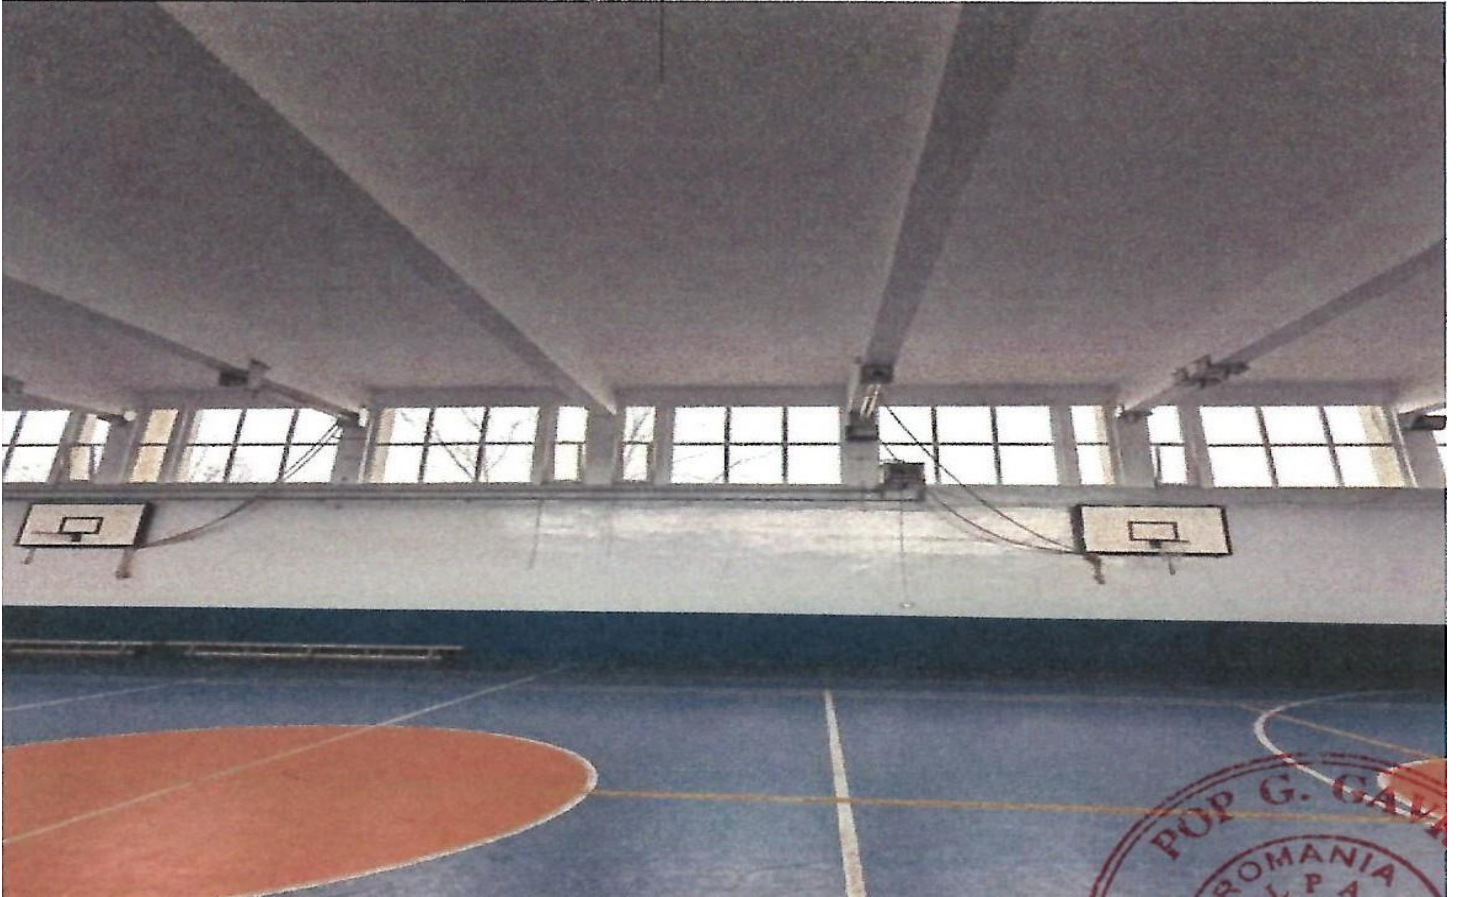
Photo 5 – Viewing from inside the gym hall, one can detect the main beams, the pillars and the longitudinal wall from N limit

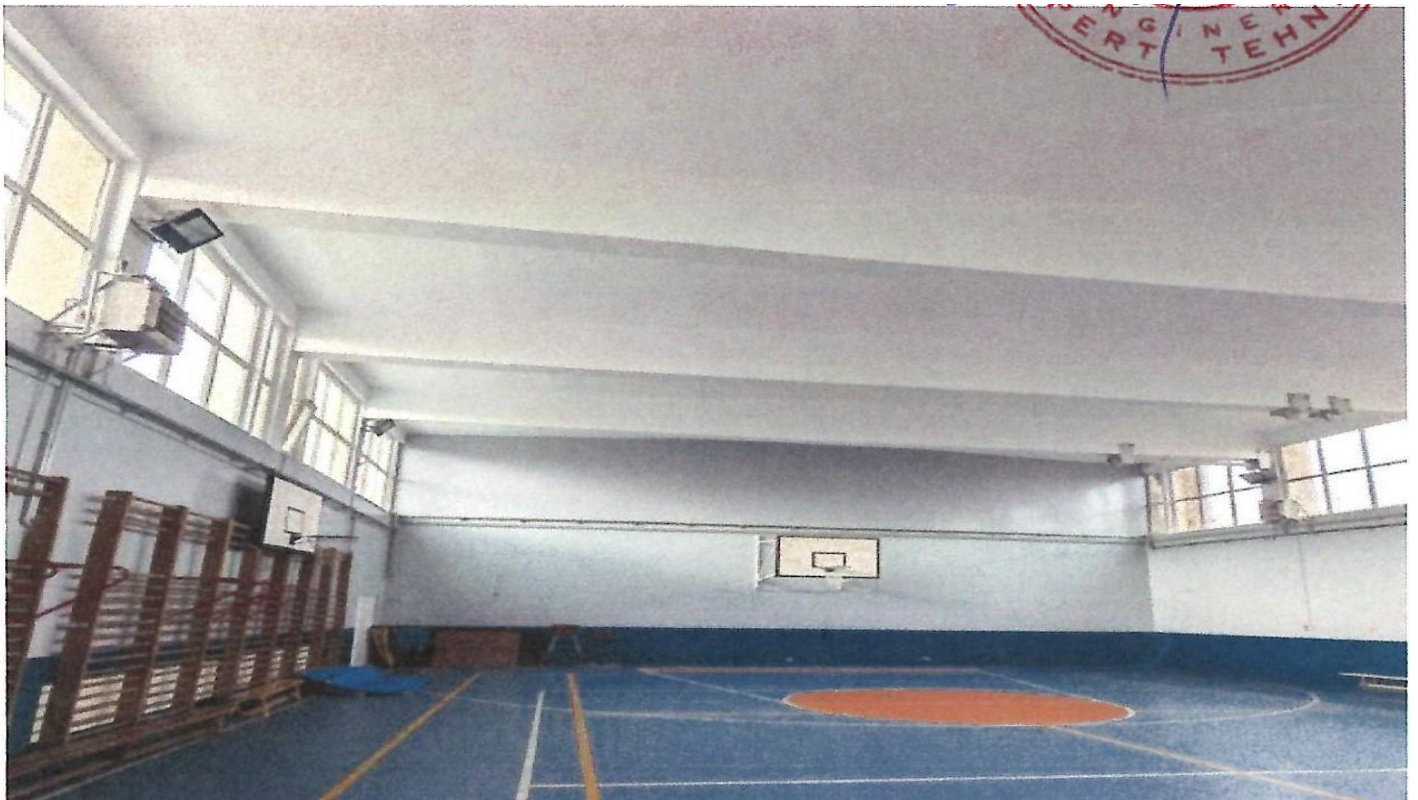
Photo 6 – Photo from inside the gym hall, one can see the beams with variable height, the main pillars and the side wall made of masonry

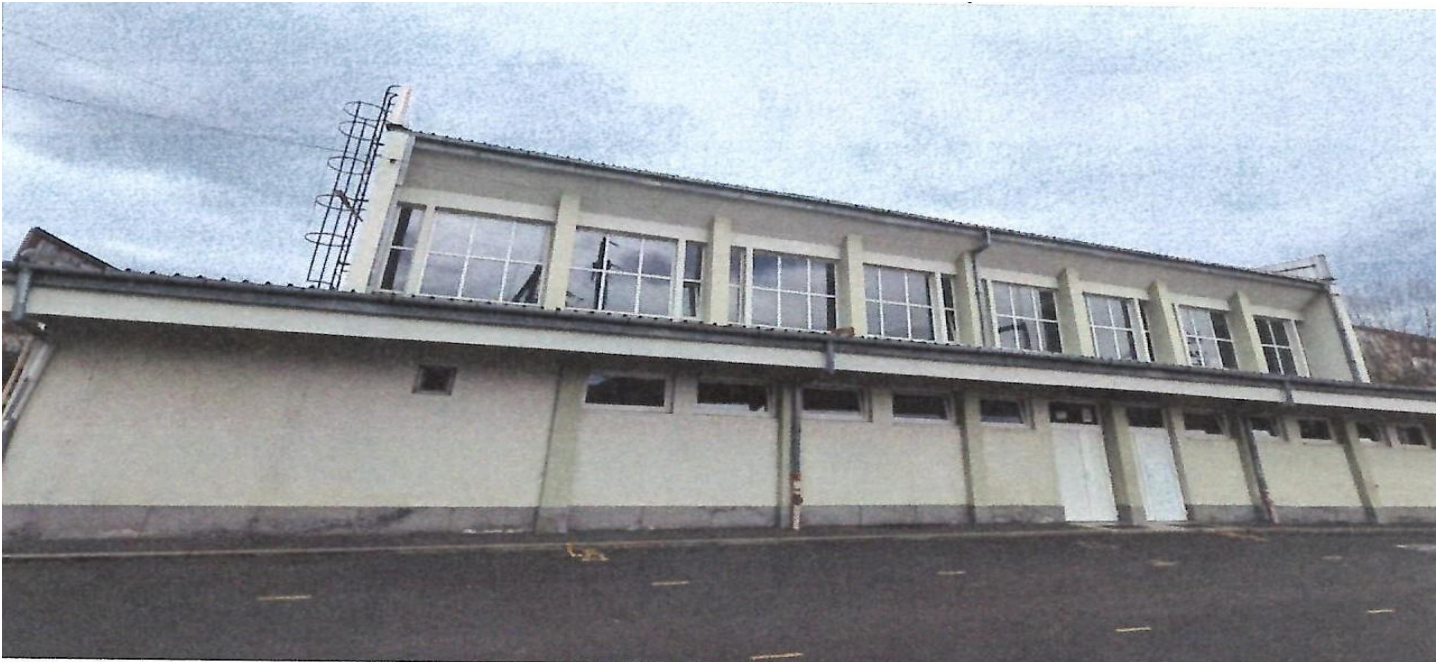
Photo 10 – Photo of the heating system and of the new roof with wood the annex roof of the gym hall
